MISCELLANEOUS PAPER S-73-23

CONDITION SURVEY, MINOT AIR FORCE BASE, NORTH DAKOTA

April 1973

Conducted by U. S. Army Engineer Waterways Experiment Station
Soils and Pavements Laboratory
Vicksburg, Mississippi

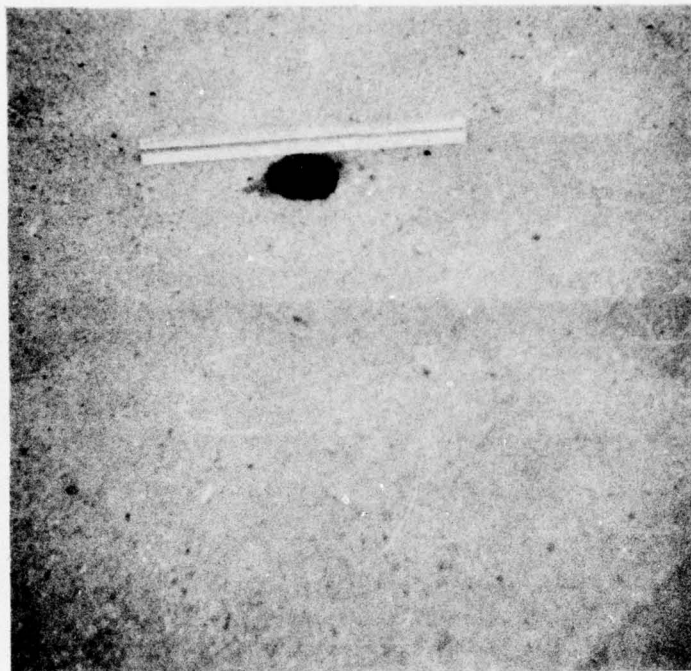
15. There were some aggregate pop-outs observed in the runway pavements, with the majority occurring in the interior section. The maximum size of the voids resulting from the pop-outs was about 3 in. in diameter (photo 1). These areas are kept free of debris by sweeping.

26. Pop-outs are occurring in some areas of the airfield, but they have not been considered a maintenance problem. The pop-outs are small in size (3-in.-diam, maximum), and patching is not required. Sweeping keeps any loose particles resulting from pop-outs off of the pavement surfaces.

Photo 1. Pop-out in runway interior
(approximately maximum size observed)

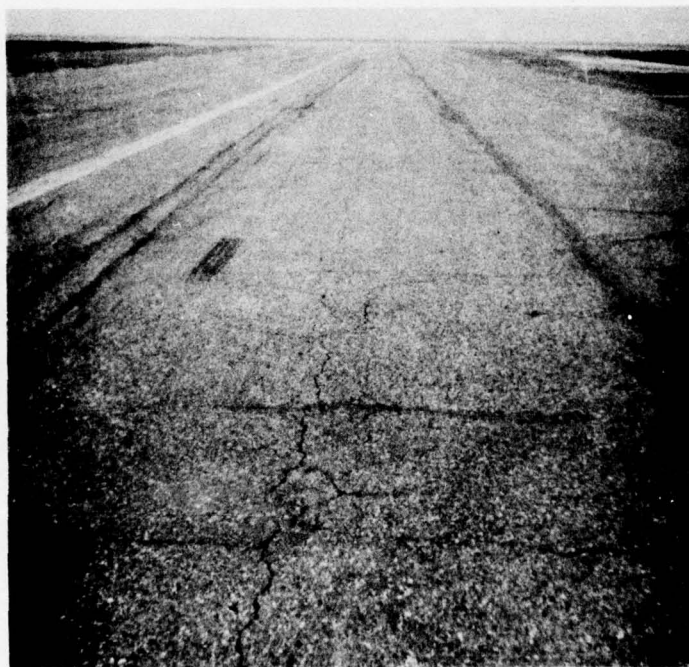
24. Both of these taxiways connecting the runway to the primary taxiway are of flexible pavement construction. The pavements were in fair condition, with random cracking in the surface (photo 2). Some longitudinal cracking occurred in taxiway C as a result of operations of aircraft during practice alerts. The taxiway was also used to park alert aircraft; and, because of the surface condition, Base Civil Engineering

Photo 2. Random cracking in taxiway C

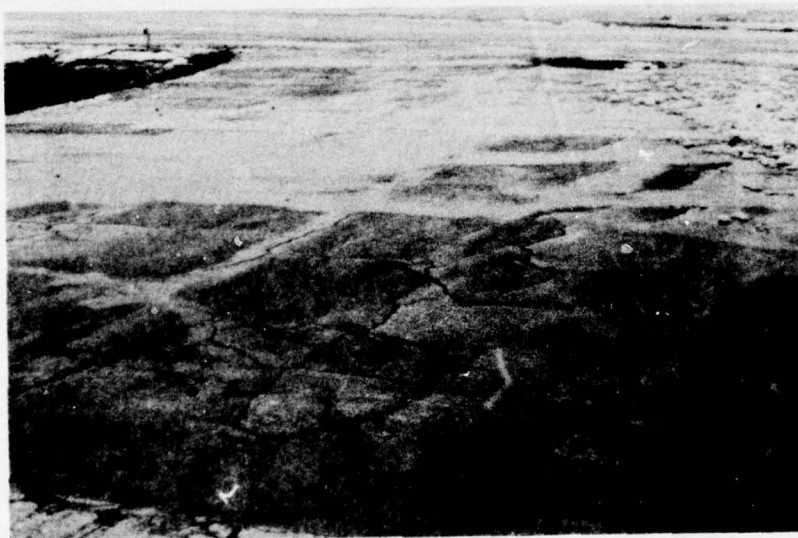
Photo 4. Random cracking of shoulder pavement at
taxiway B caused by nonuniform frost heave

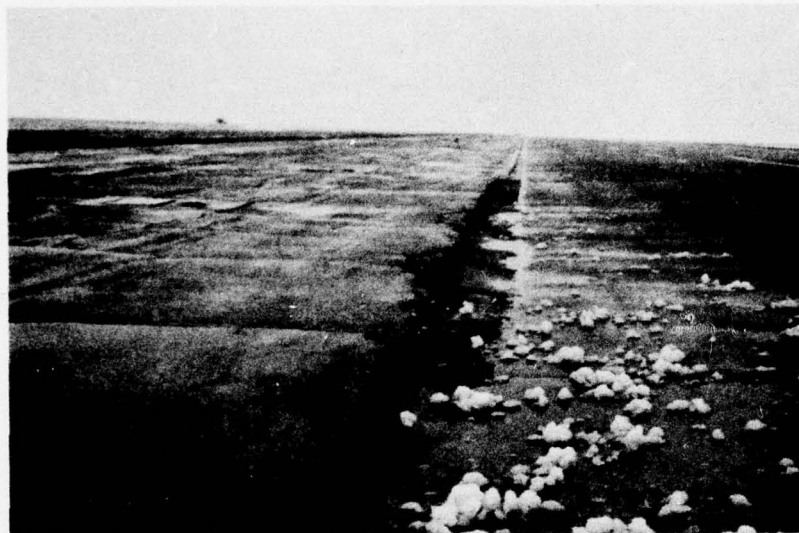
Photo 5. Shoulder pavement of parallel taxiway
heaved 1-1/2 in. above edge of feature T11A

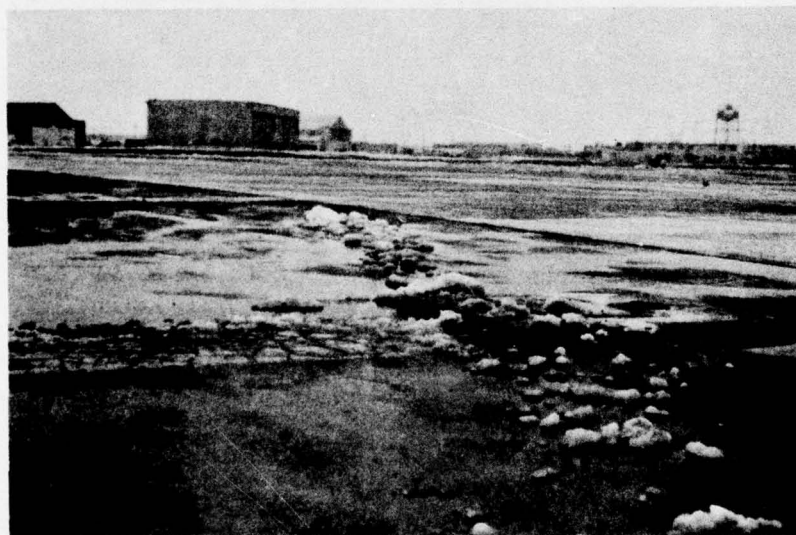
Photo 6. Differential frost heave at concrete
insert in shoulder of taxiway B

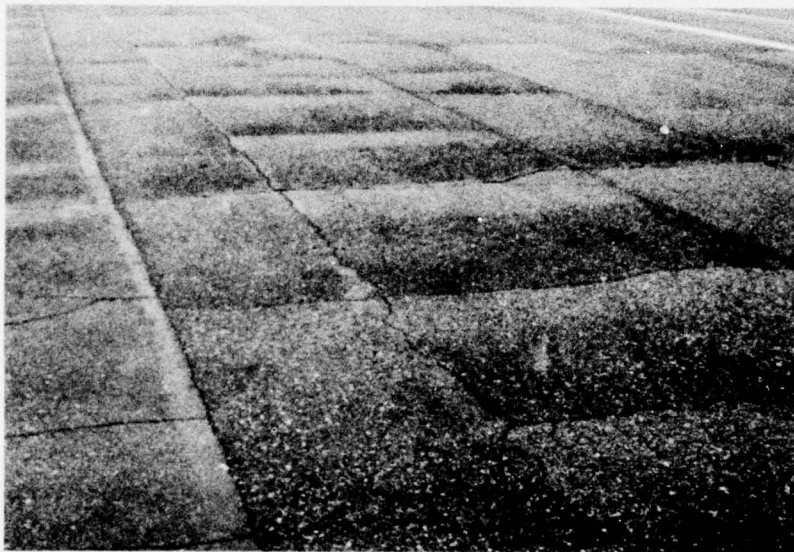
37. All of the AC pavements at MAFB have been adversely affected by low-temperature contraction cracking. This type of cracking, which is not induced by either traffic or frost heave, results from a stiffness characteristic of AC at low temperatures and its inability to withstand or adjust to thermal contraction stresses. As a general rule, contraction cracking is transverse to the center line of a facility; but, at MAFB (where the crack spacing is only about 10 to 15 ft), longitudinal cracks are nearly as prevalent as transverse cracks in some of the pavements. Photo 7 shows the primary taxiway (feature T11A) where contraction cracks are evident in the pavement of both the taxiway and the shoulder. The heavy-load flexible pavements along edges of the runway are similarly cracked. However, the cracks in the runway and taxiway pavements do not seem to have adversely affected either the load-bearing capacity or the riding quality (smoothness) of the pavement. Ravelling of the bituminous mixture at the cracks also has not been severe, as yet, but is expected to become progressively worse.

Photo 7. Transverse and longitudinal low-temperature contraction cracks at spacing of 10 to 15 ft in edge of primary taxiway (feature T11A)

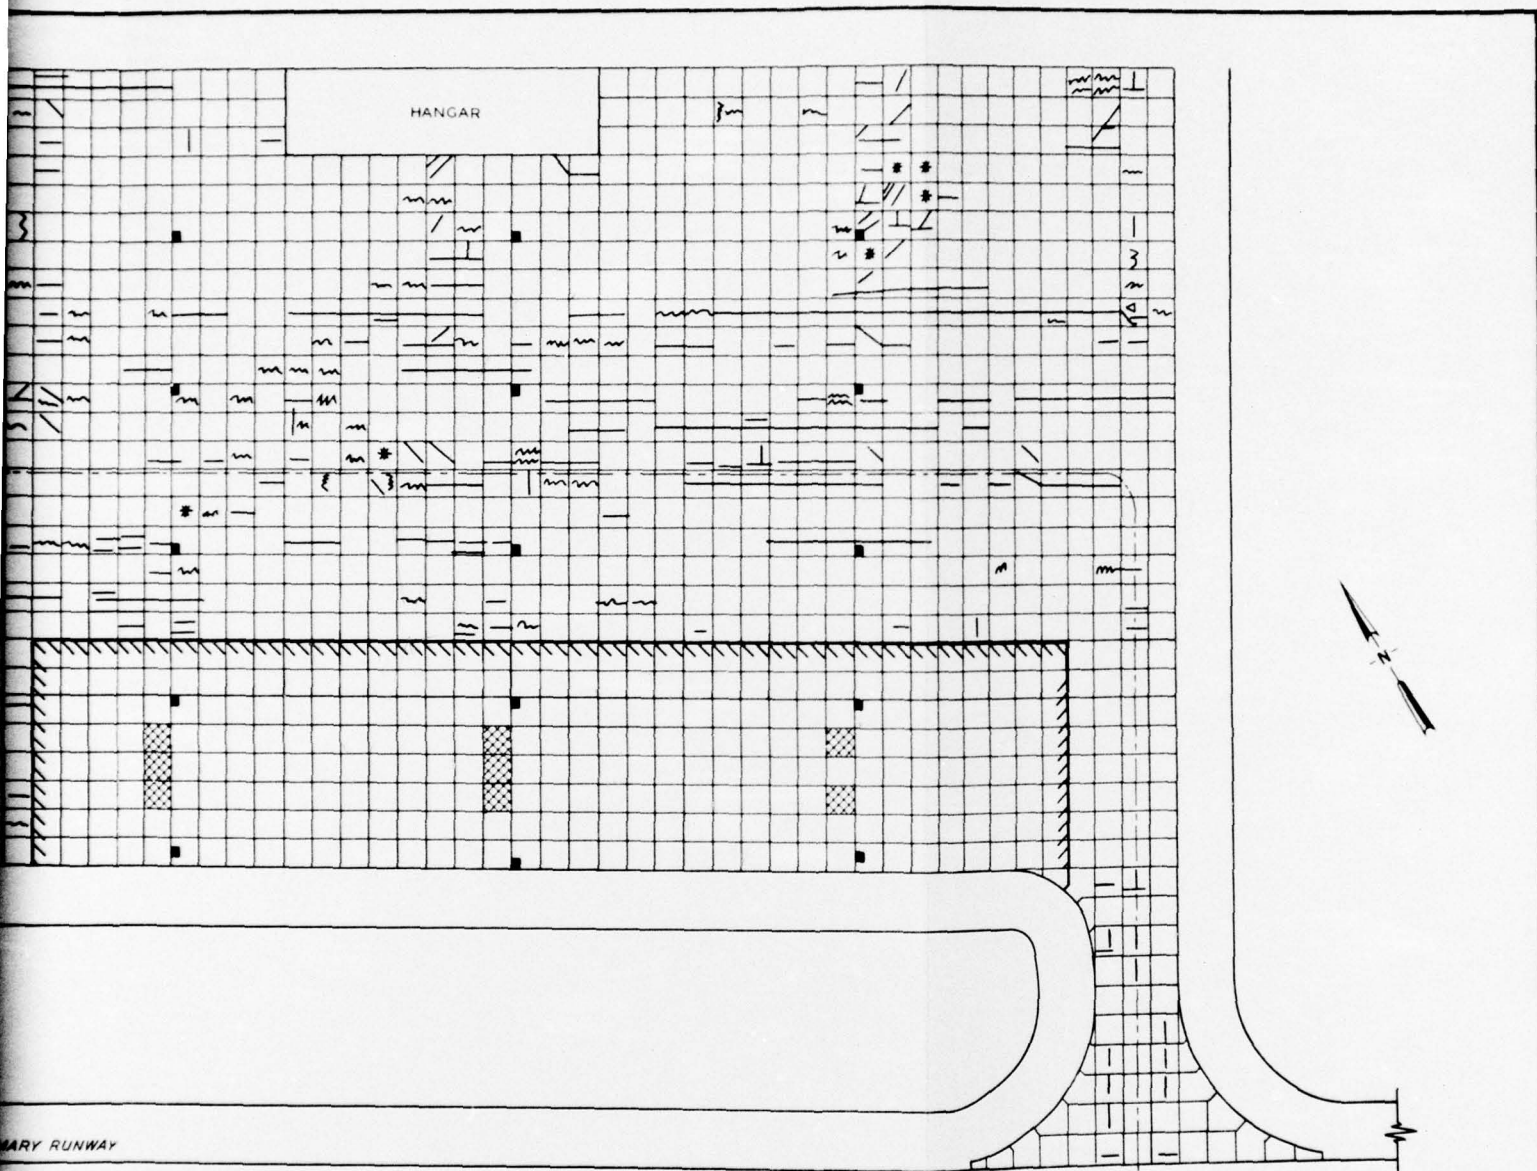
PLATE 4

20. The large operational apron consists of 15-in. PCC, with 25-by 25-ft slabs composing the original portion (feature A3B). The overall condition of the apron was very good, with approximately 19 percent of the slabs containing major defects. A comparison of the number of 1972 defects with the number of 1960 defects (table 4) indicates that the original apron (feature A3B) has had a significant increase in the number of defects. Plate 4 shows the locations and types of defects as observed in 1972. It was possible to survey only a few areas where alert aircraft parked. In these areas, considerable distress in the slabs had occurred, especially in those slabs on which aircraft wheels are usually located. Furthermore, vibrations are transferred from the aircraft to the slabs during run-up operations; and, in almost every parking spot, the slabs were shattered, and, in some cases, displacement and faulting had occurred.

DEFECTS IN SAC
OPERATIONAL APRON
MINOT AFB, NORTH DAKOTA
